# HARO, KASUNICH AND ASSOCIATES, INC.

19 July 2024  
Project No. M12112.1

Subject: Geologic and Coastal Bluff Recession Assessment Report

Reference: 35700 Highway 1, Big Sur, CA 93920  
Monterey County APN 243-231-014-000

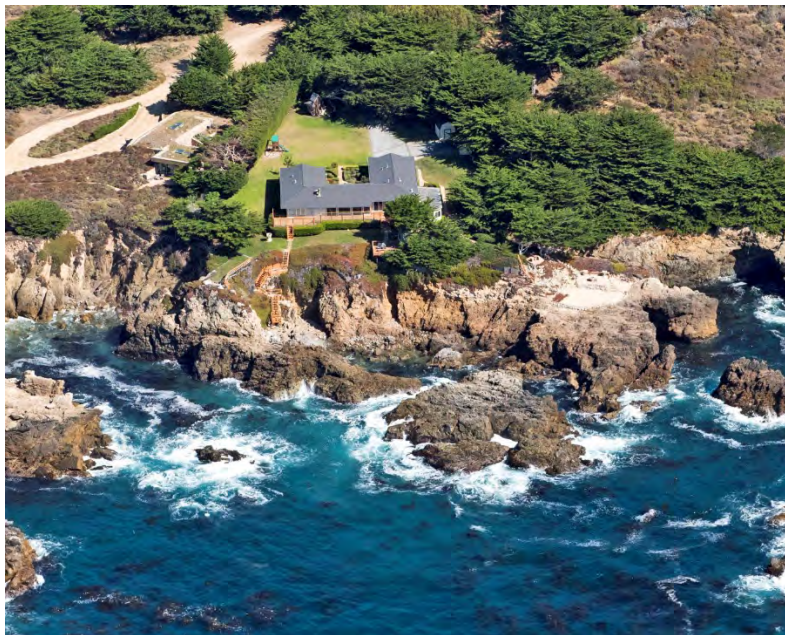
**Photograph 5: Aerial Photograph from October 2, 2019  
(courtesy of [www.californiacoastline.org](http://www.californiacoastline.org))**

We examined the bluff face on April 25, 2024 and found the geologic and geomorphic conditions to be virtually identical to those in the October 2019 photograph below:

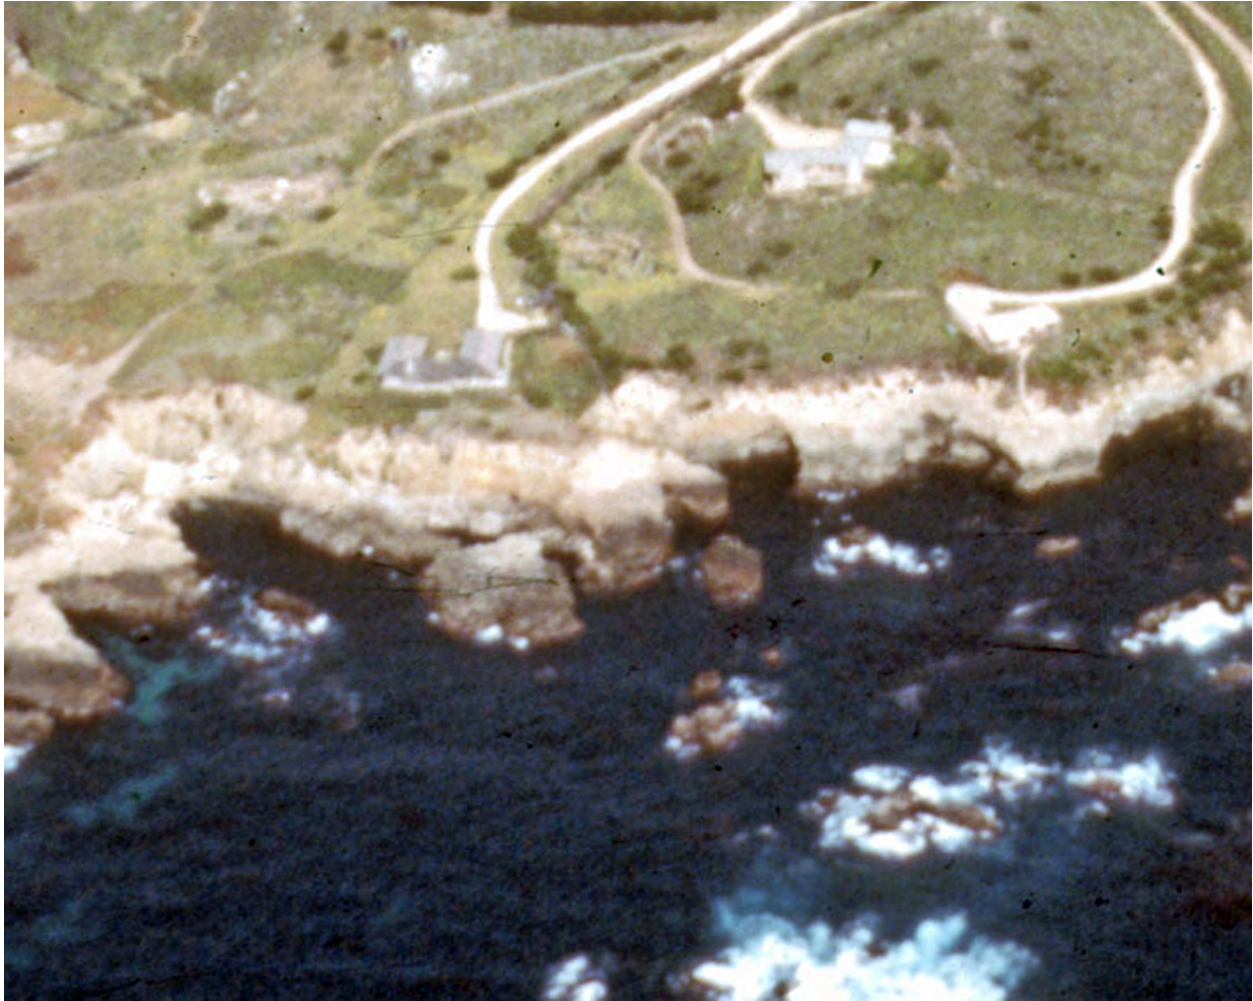
**Photograph 15: Aerial Photograph from 1972**  
(courtesy of [www.californiacoastline.org](http://www.californiacoastline.org))

The 1972 photograph below shows the home in the oldest photo available; from 52 years ago.

The historical long term average annual recession rate of the terrace deposits that appears to have historically occurred on the property since 1972 (52 years) has been about 0.5 to 1 inches per year suggests that about 3 to 6 feet of marine terrace deposit erosion could cause 3 to 6 feet of recession of the bluff edge in the next 75 years. To account for future sea level rise of 4.6 feet during the next 75 years, we have conservatively increased this marine terrace and soil retreat amount by 50% to be 4.5 to 9 feet in the next 75 years.

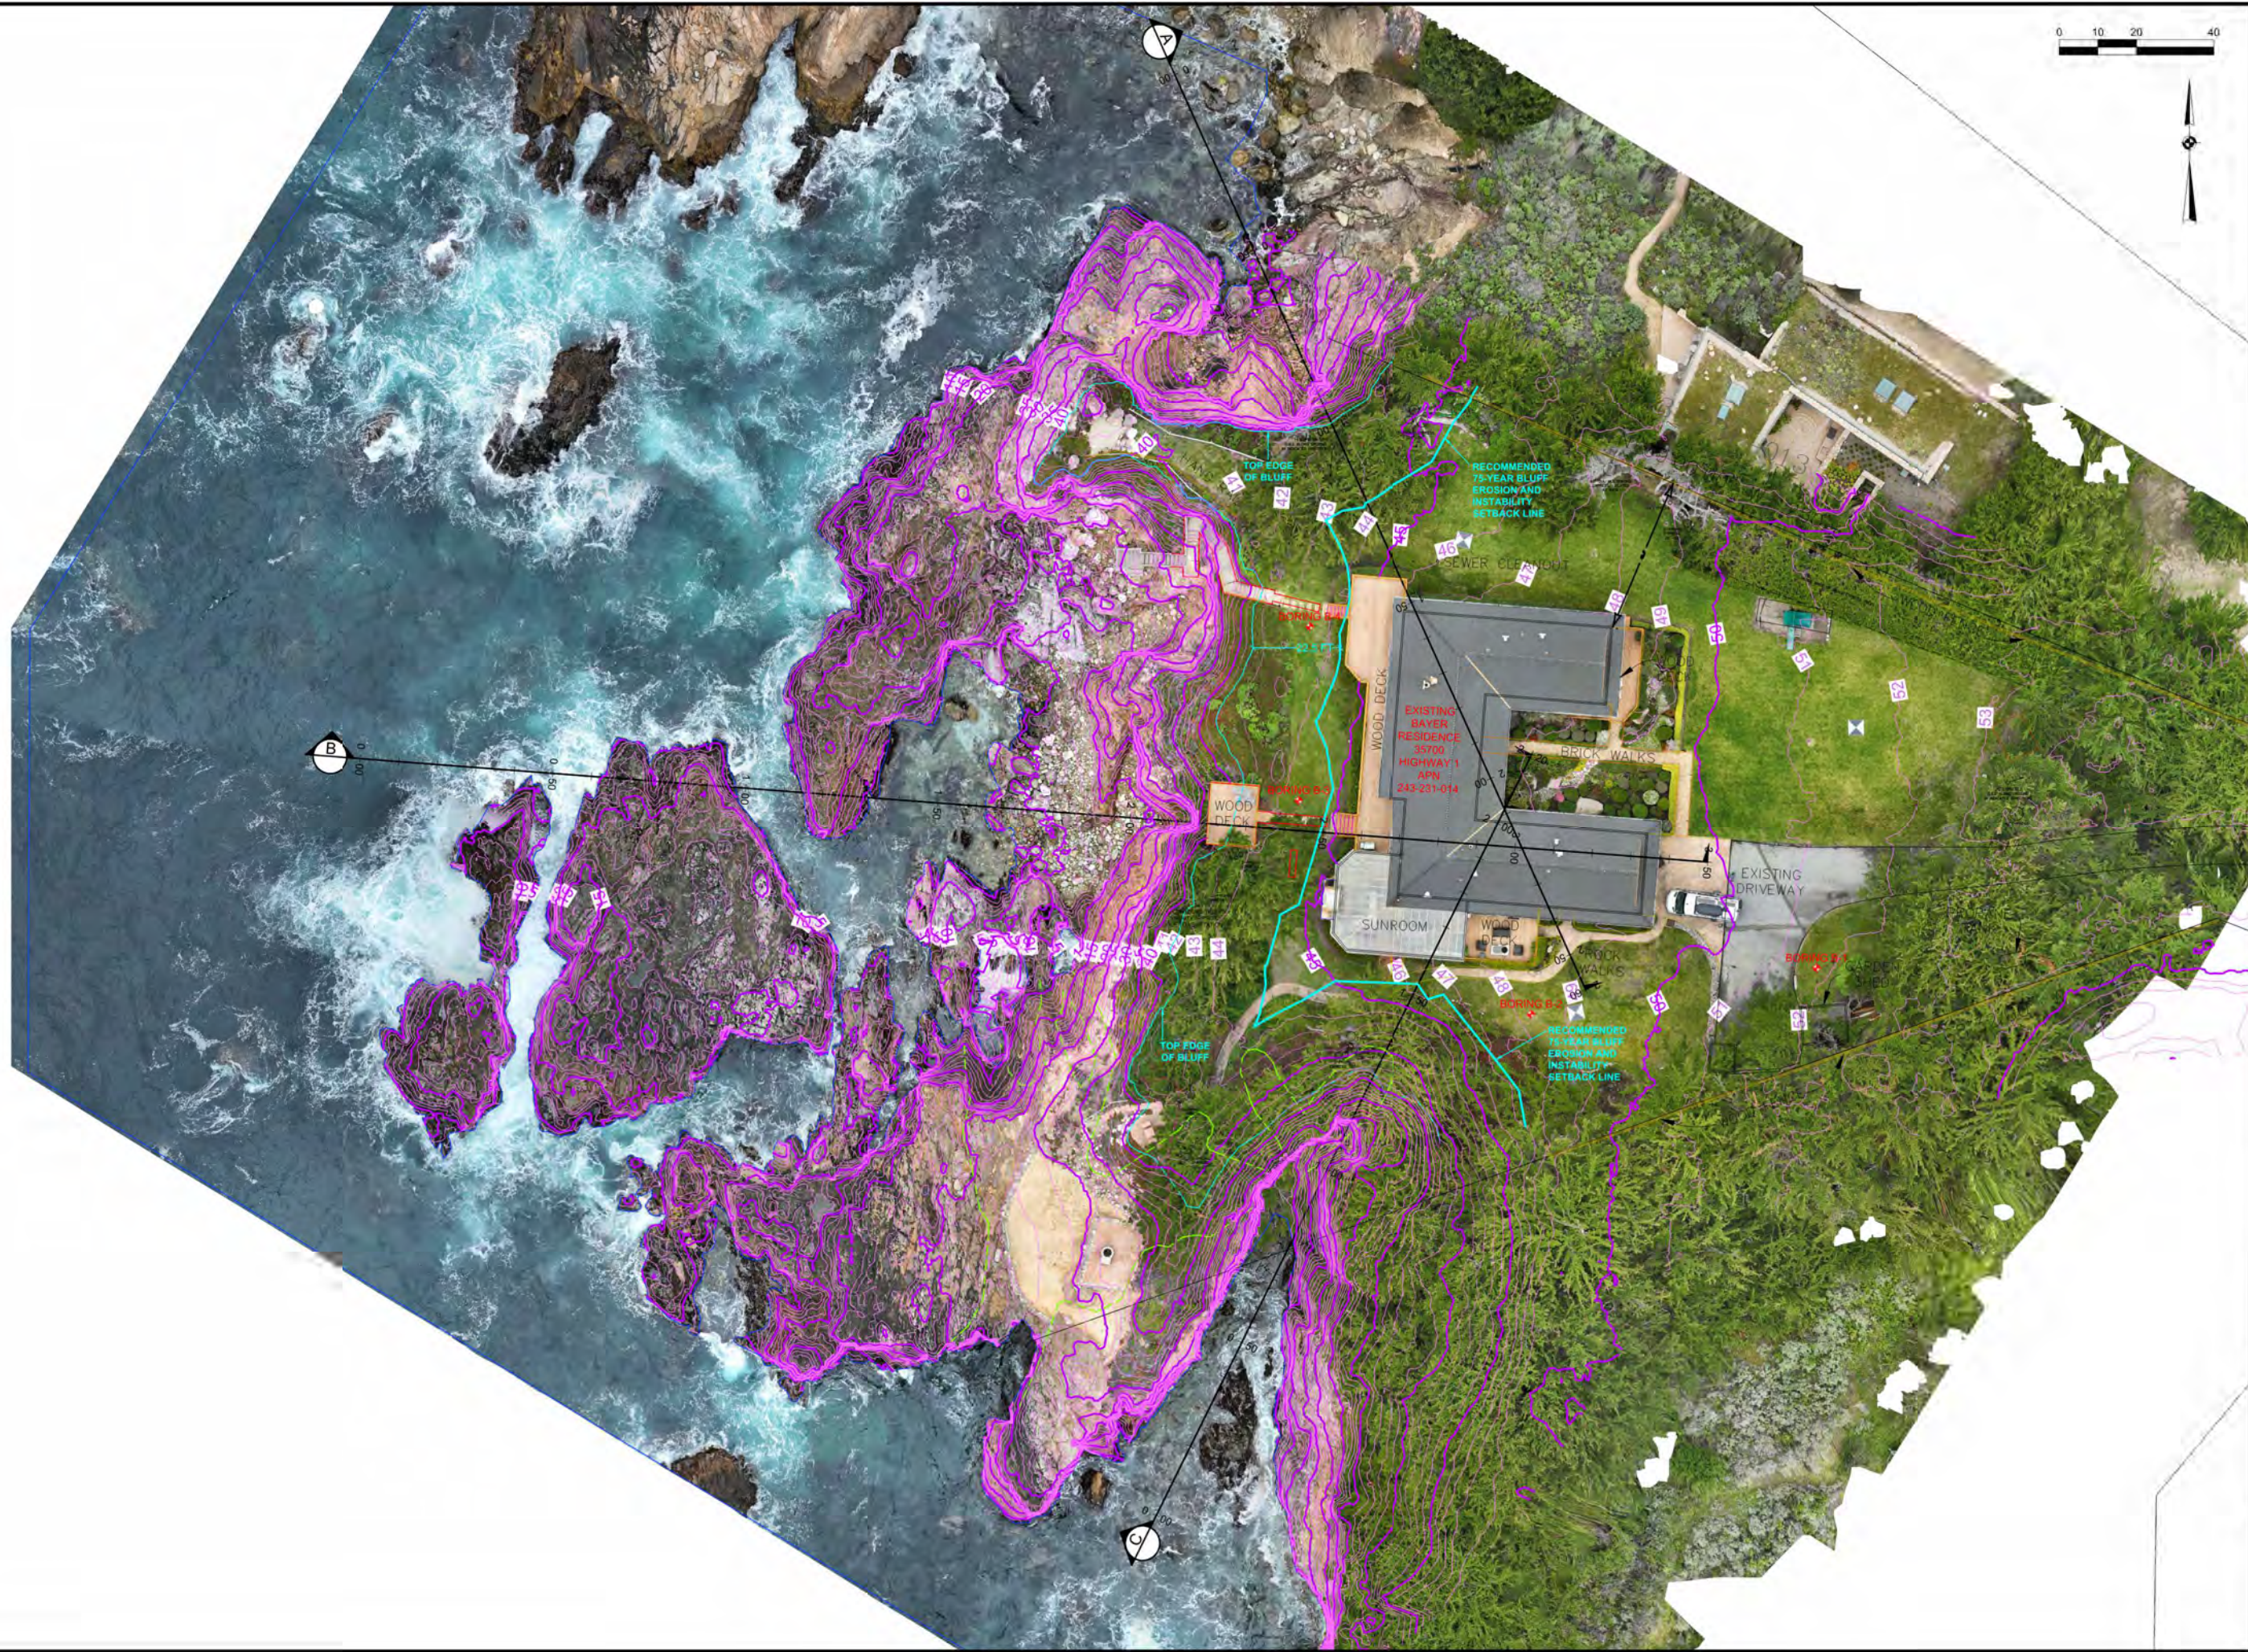
RECOMMENDED 75-YEAR COASTAL BLUFF EROSION  
AND INSTABILITY SETBACK MAP  
BAYER RESIDENCE 35700 HIGHWAY 1, MONTEREY, CA 93940 APN 243231014

We have shown 22.5 feet of retreat of the top edge of the coastal bluff on both the Map Cross Sections A through C on our RECOMMENDED 75-YEAR COASTAL BLUFF EROSION AND INSTABILITY SETBACK MAP AND CROSS SECTIONS (Three 11 X 17 inch sheets dated 7-19-2024) in Appendix B of this report. This Map and Cross Sections show what portion of the property is likely to remain stable for 75 years (until 2099) and show our RECOMMENDED 75-YEAR BLUFF EROSION AND INSTABILITY SETBACK LINE 22.5 feet inland of where we have mapped the top edge of the existing coastal bluff.

4. At the subject property, we recommend that areas seaward of the RECOMMENDED 75-YEAR COASTAL BLUFF EROSION AND INSTABILITY SETBACK MAP AND CROSS SECTIONS (Three 11 X 17 inch sheets dated 7-19-2024) shown in Appendix B be considered to be at potential risk in the next 75 years (by 2099). This map and the accompanying cross sections show our RECOMMENDED 75-YEAR COASTAL BLUFF EROSION AND INSTABILITY SETBACK LINE 22.5 feet inland of where we have mapped the top edge of the existing coastal bluff.

- 1) At the subject property, we recommend that areas seaward of the RECOMMENDED 75-YEAR BLUFF EROSION AND INSTABILITY SETBACK MAP AND CROSS SECTIONS (Three 11 X 17 inch sheets dated 7-19-2024) shown in Appendix B be considered to be at potential risk in the next 75 years (by 2099). We recommend that new habitable development only be constructed inland of this setback. It is possible that any development or improvements seaward of this setback may be damaged by coastal erosion, bluff retreat and/or bluff instability during the next 75 years.
