**ELLA INDUSTRIES INC (PLN190155)**

**RESOLUTION NO. 25-058**

# A PLAN FOR REMEDIATING AN HISTORIC ROADBED & ASSOCIATED LANDSCAPE RESOURCES ON AN UNDEVELOPED PRIVATE PROPERTY NEAR ROYAL OAKS IN MONTEREY COUNTY, CALIFORNIA

**REPORT:**      **REMEDATION PLAN FOR A ROADBED AND ASSOCIATED  
LANDSCAPE RESOURCES ON PRIVATE PROPERTY NEAR ROYAL  
OAKS IN MONTEREY COUNTY, CA.**

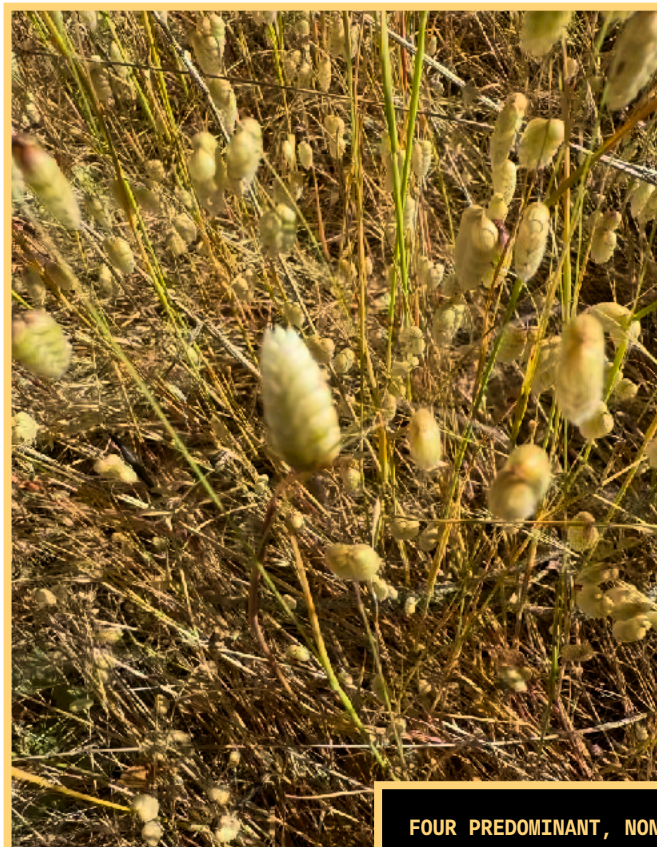
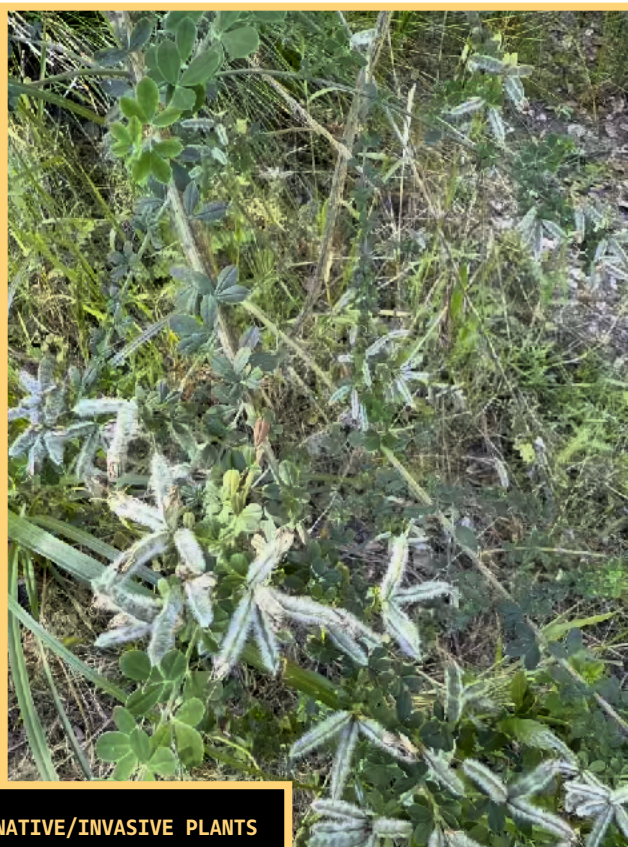
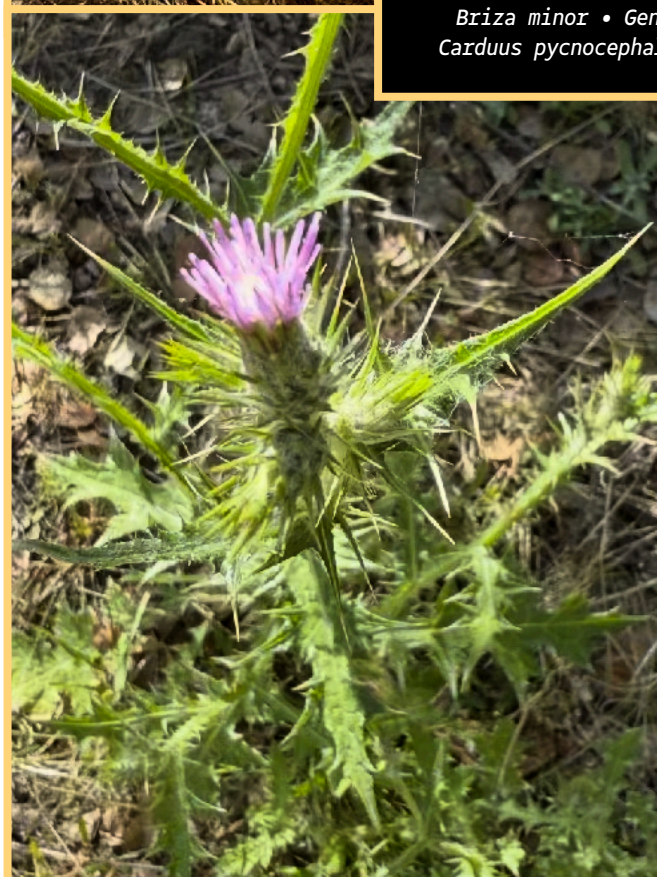
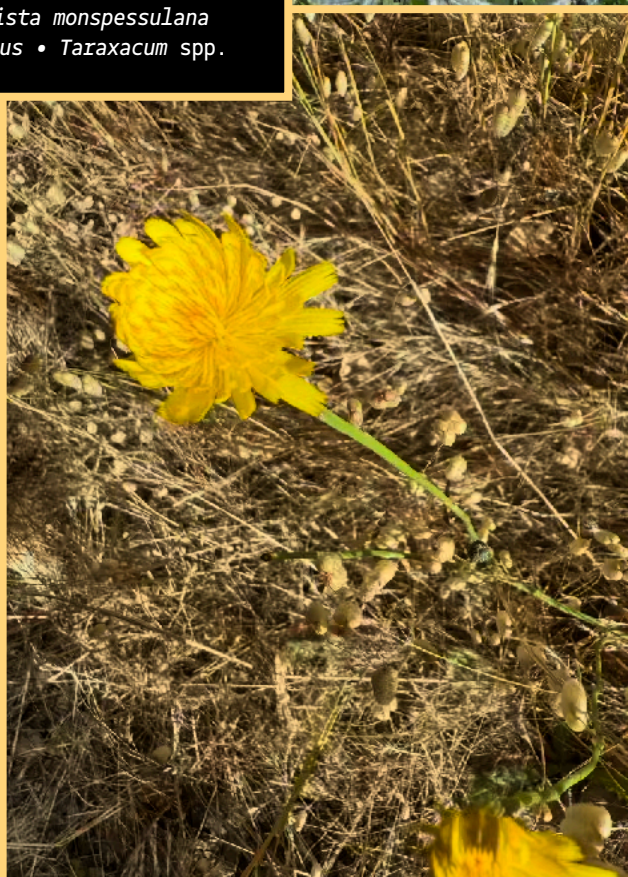
**FOUR PREDOMINANT, NONNATIVE/INVASIVE PLANTS**

*Briza minor* • *Genista monspessulana*  
*Carduus pycnocephalus* • *Taraxacum* spp.
