**Wetland and Waterbody Delineation Report**

**HAVEN HILL ACRES  
COLLINSVILLE, ILLINOIS**

**July 23, 2025**

**SCI No. 2023-1906.30**

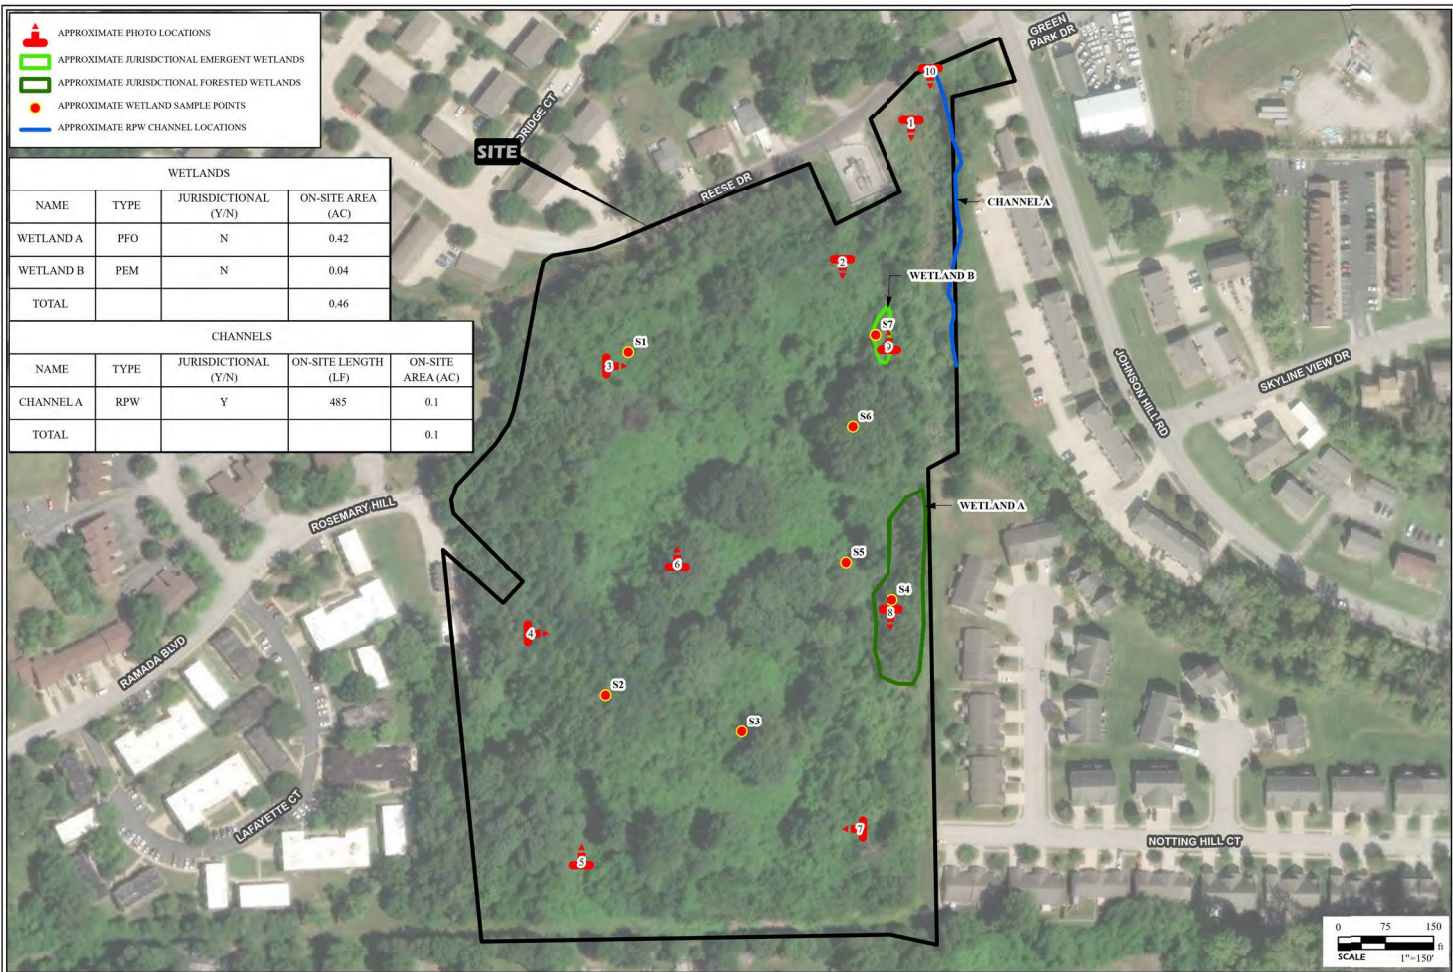
FIGURE  
4

During our site visit, one RPW (Channel A), one emergent wetland (Wetland B) and one forested wetland (Wetland A) was identified. The identified RPW is anticipated to be considered a jurisdictional WOTUS and would likely be regulated by the USACE. A photographic summary of the identified features as well as representative site conditions is enclosed as Appendix B. The *Automated Wetland Determination Data Forms* are enclosed as Appendix C. Additionally, the features identified are illustrated on Figure 4 - *Wetland Delineation and Aerial Photograph*.

WETLANDS			
NAME	TYPE	JURISDICTIONAL (Y/N)	ON-SITE AREA (AC)
WETLAND A	PFO	N	0.42
WETLAND B	PEM	N	0.04
TOTAL			0.46

CHANNELS				
NAME	TYPE	JURISDICTIONAL (Y/N)	ON-SITE LENGTH (LF)	ON-SITE AREA (AC)
CHANNEL A	RPW	Y	485	0.1
TOTAL				0.1

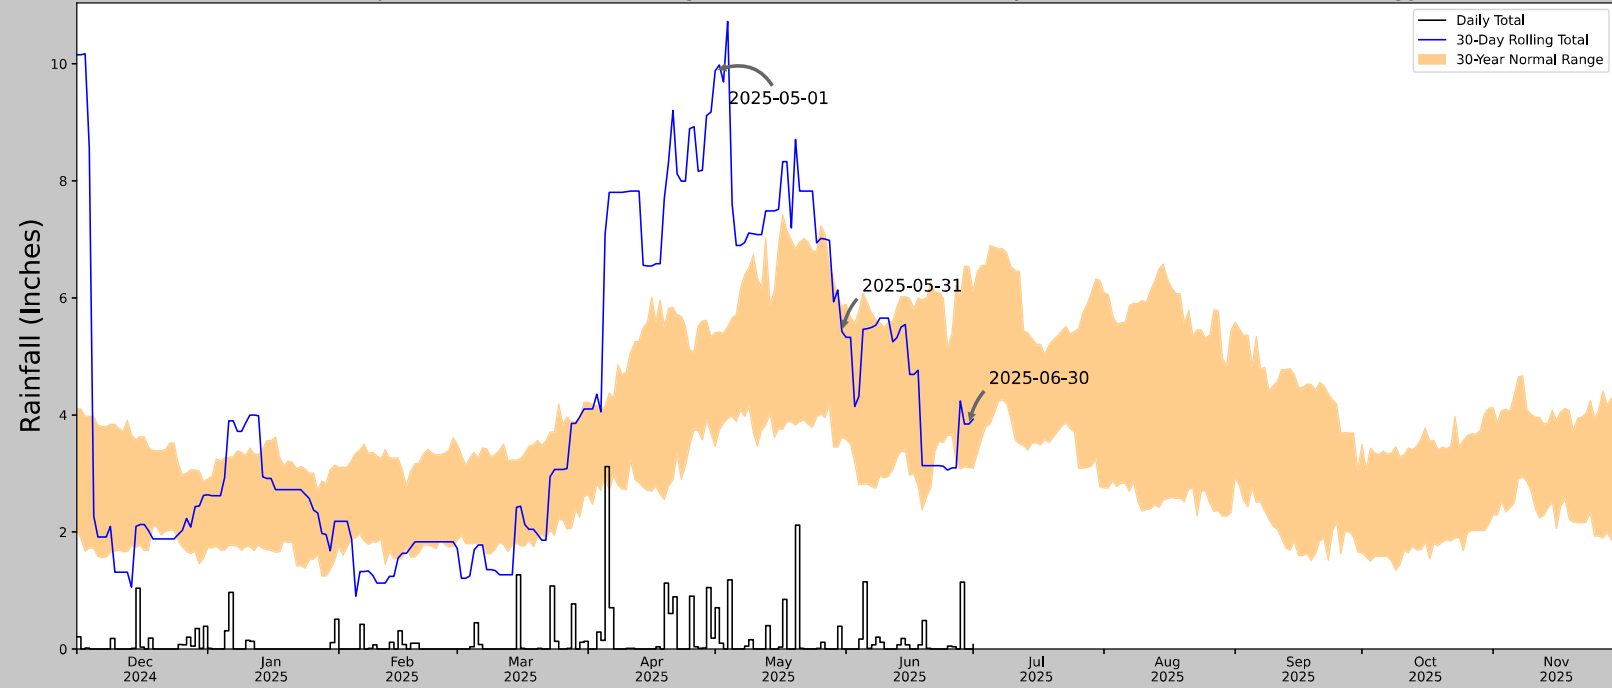
The USACE Antecedent Precipitation Tool (APT) was utilized to calculate the normal range of precipitation for the project area, including whether the area was experiencing a drought at the time of the delineation. The APT calculation indicates that the area was experiencing “Normal” conditions within the three months prior to the survey compared against 30 years of climate data, and that the area was also within the “Dry Season” at the time of the wetland and waterbody delineation. The drought index was unavailable. The APT data is included within Appendix A. Prior to our site visit, the project area experienced a recent precipitation event on June 28, 2025, resulting in approximately 0.7 inches of rain.

## Antecedent Precipitation vs Normal Range based on NOAA's Daily Global Historical Climatology Network

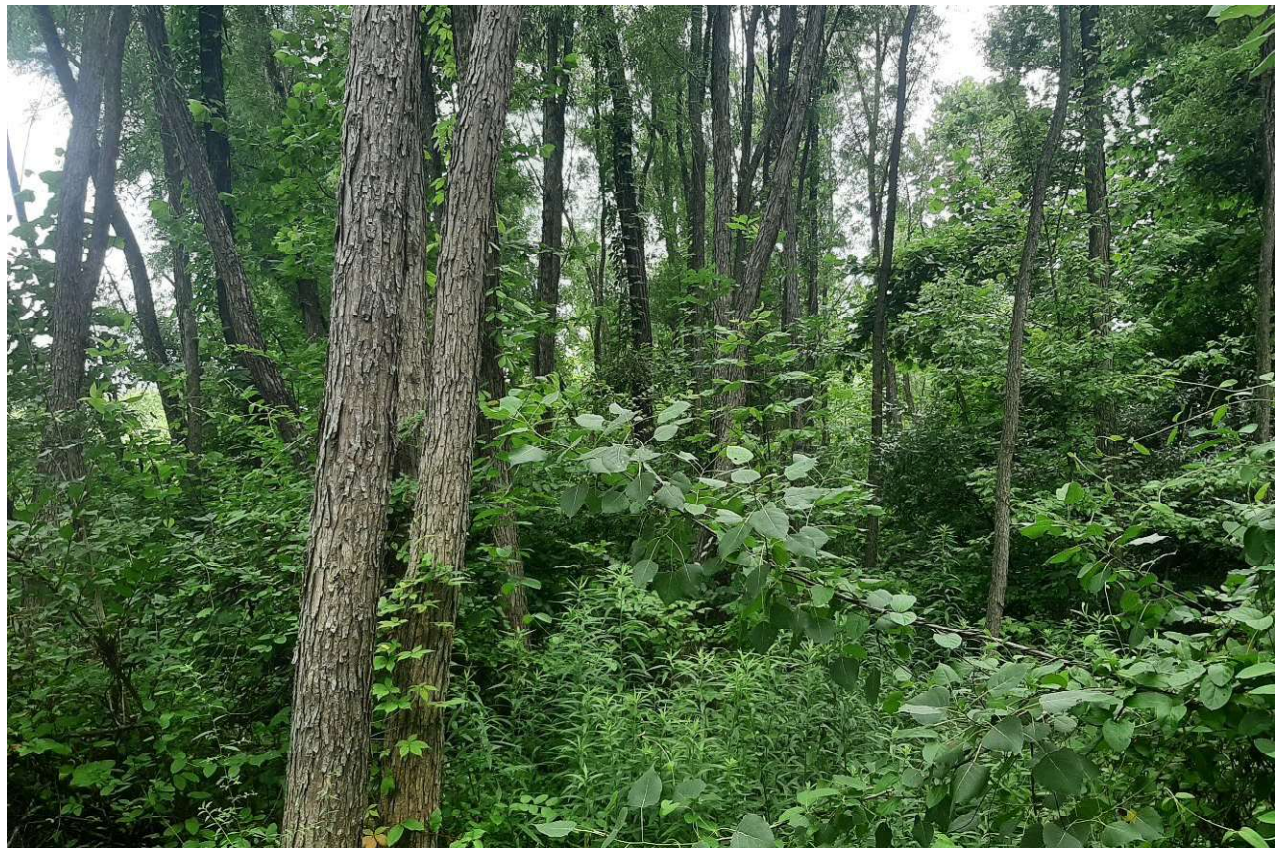
**Wetland A** is an approximately 0.42-acre forested wetland in the eastern section of the site. Wetland A was observed to be within a depression and surrounded completely by upland. The dominant vegetation within the wetland community was black willow (*Salix nigra*), northern spicebush (*Lindera benzoin*), and common jewelweed (*Impatiens capensis*). The hydric soil indicator of depleted matrix was observed within the wetland boundary. Observed hydrological wetland indicators included geomorphic position, and the FAC-neutral test. Based on the observed characteristics and lack of a continuous surface connection to a WOTUS, this feature would likely be considered non-jurisdictional by the USACE.

Photo 8. Overview of Wetland A, facing south.

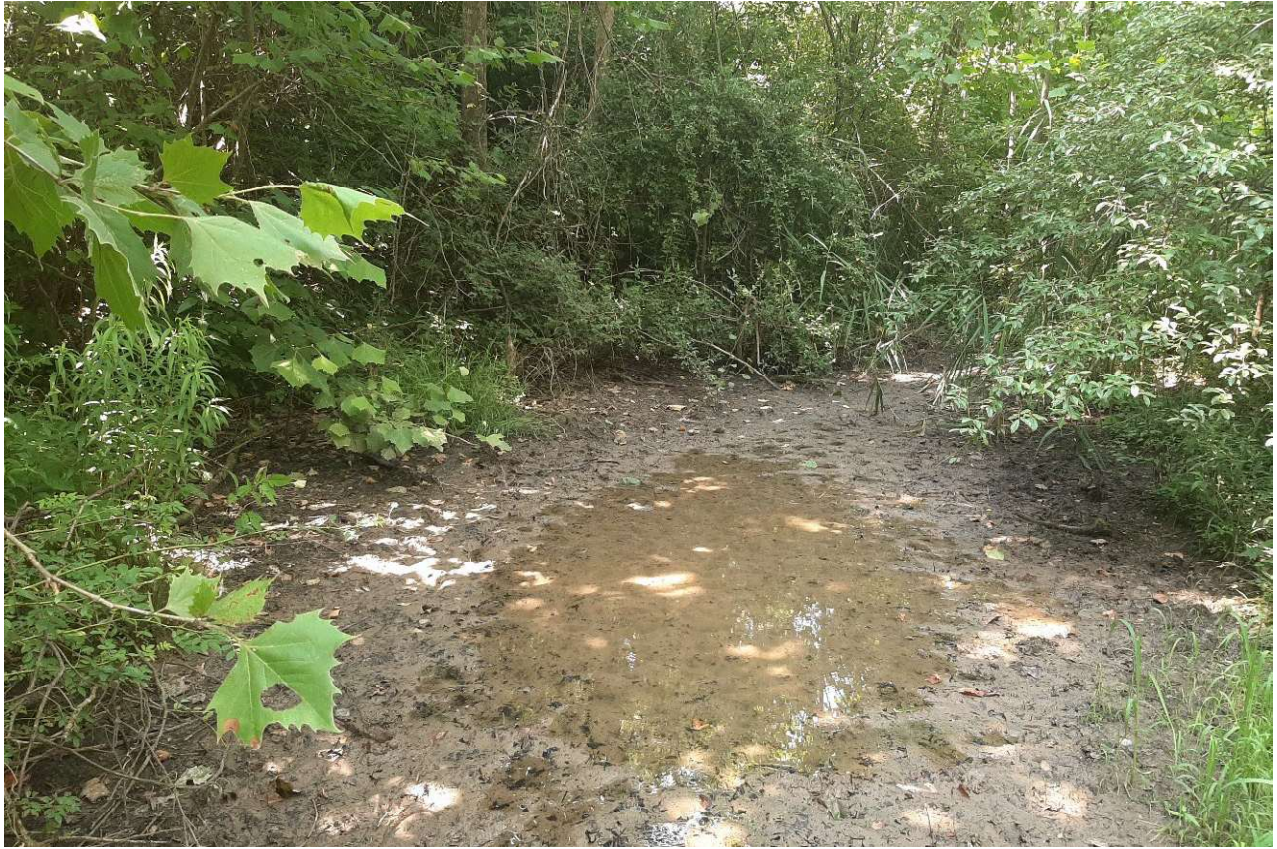
**Wetland B** is an approximately 0.04-acre emergent wetland in the northeastern section of the site. Wetland B was observed to be within a depression and surrounded completely by upland. The dominant vegetation within the wetland community was rice cutgrass (*Leersia oryzoides*), tall goldenrod (*Solidago gigantea*), and American sycamore. The hydric soil indicator of depleted matrix was observed within the wetland boundary. Observed hydrological wetland indicators included surface water, geomorphic position, and the FAC-neutral test. Based on the observed characteristics and lack of a continuous surface connection to a WOTUS, this feature would likely be considered non-jurisdictional by the USACE.

Photo 9. Overview of Wetland B, facing north.

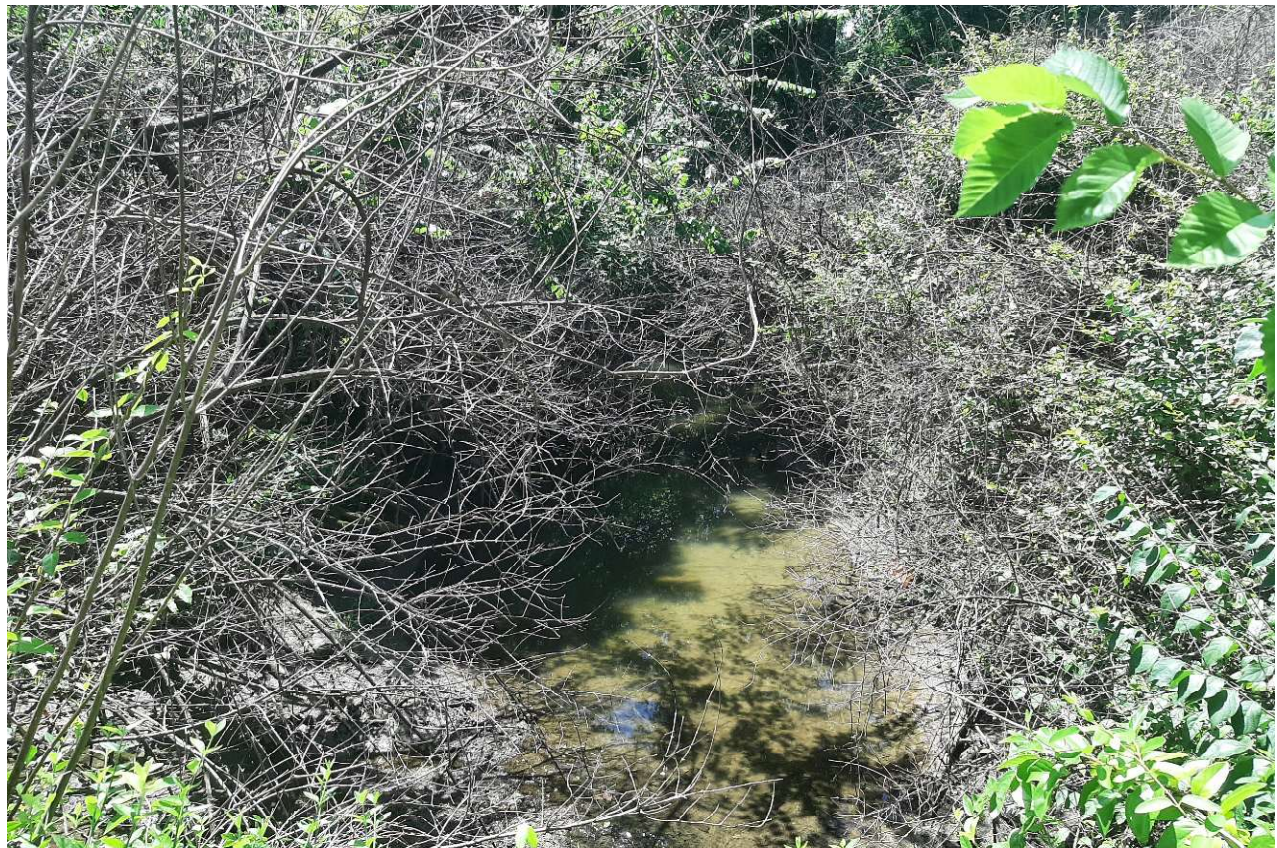
**Channel A** is an RPW feature which flows through the northeastern portion of the site. This feature originates off site and drains through the northeast corner of the site for approximately 485 feet draining north before exiting the site along the north boundary. Channel A is a Stream Order 3 channel in accordance with Strahler’s stream ordering system. The channel was observed to possess an Ordinary High-Water Mark (OHWM) of

approximately 8 to 10 feet in width, a top-of-bank width of approximately 10 to 12 feet, and a bank height of approximately 6 feet on average. The channel's substrate consisted of silt, loam, gravel, and bedrock. Water was observed flowing through the channel at the time of our visit and was approximately 1 foot deep. Based on the observed characteristics and its relatively permanent waterflow, this feature would likely be considered a WOTUS and would likely be considered jurisdictional by the USACE.

Photo 10. View of Channel A in the northeastern corner of the site, facing south.
