# HARO, KASUNICH AND ASSOCIATES, INC.

19 July 2024  
Project No. M12112.1

Subject: Geologic and Coastal Bluff Recession Assessment Report

Reference: 35700 Highway 1, Big Sur, CA 93920  
Monterey County APN 243-231-014-000

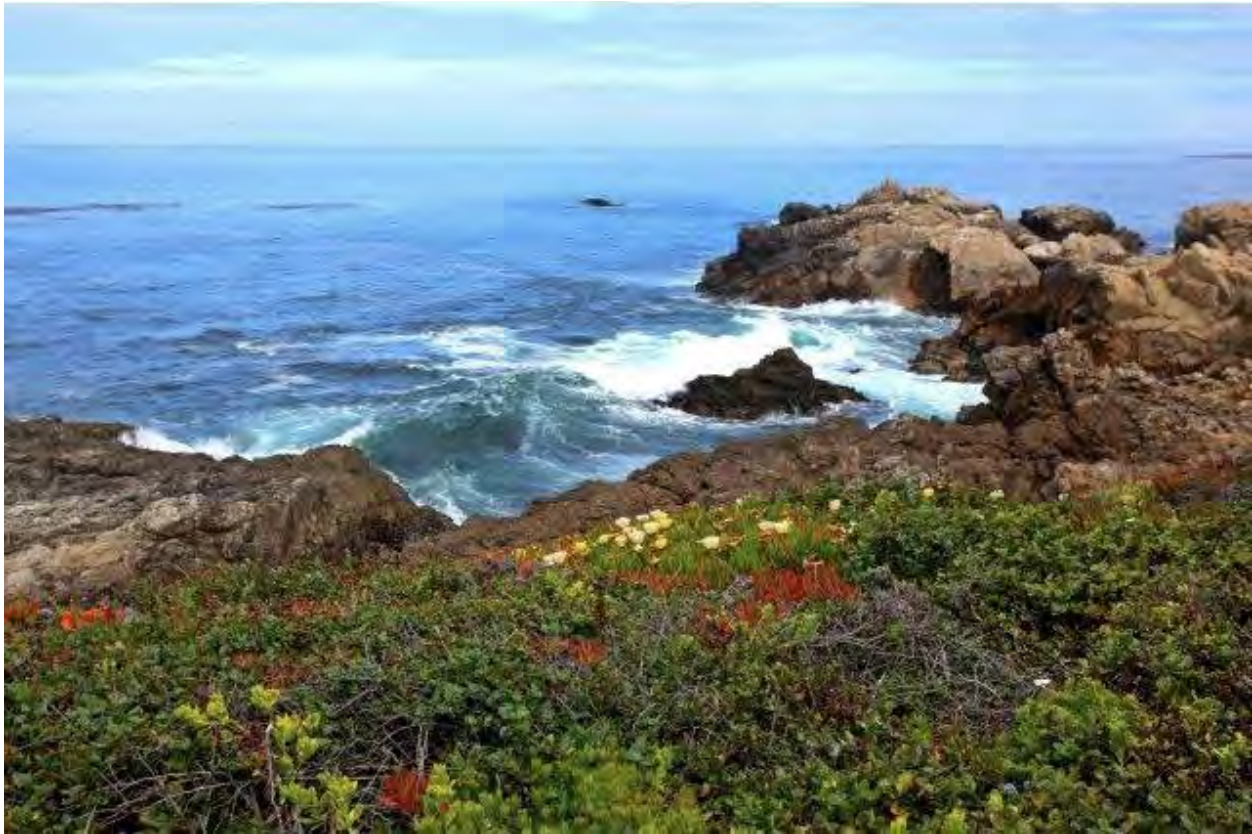
**Photograph 3: 2022 Photograph Looking Offshore**

The geologic conditions at the site, as seen in the coastal bluff face; with erosion resistant sandstone bedrock exposed in the bluff up to about an elevation of 20 to 25 feet NAVD88 or higher along the bluff. A seacave complex exists in the sandstone at the lowermost portion of the bluff on the downcoast (southern) portion of the property. Photograph 3 below shows the bluff in that area and the mouth of the seacave.

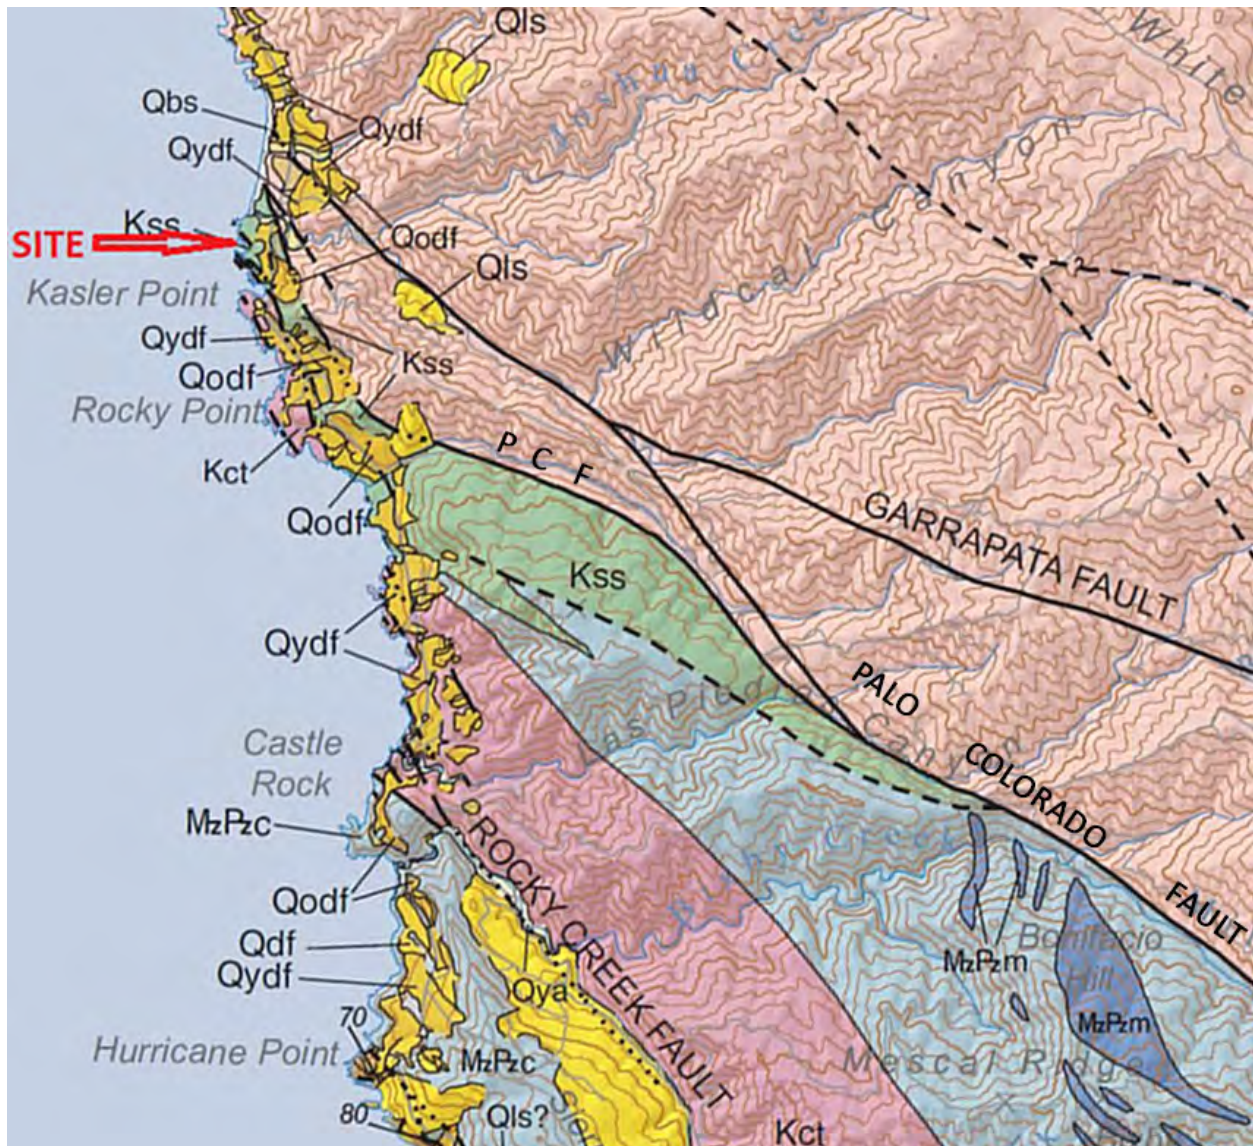
**Figure 7: California Geological Survey Regional Geologic Map  
Marked Up to Show Palo Colorado Fault Name  
(Point Sur Quadrangle, Rosenberg and Wills, 2016)**

Figure 7 (below) shows the California Geological Survey Regional Map (previously shown in Figure 3) marked up label the Palo Colorado Fault on it, which at its closest point is mapped approximately 800 feet northeast of the homesite.

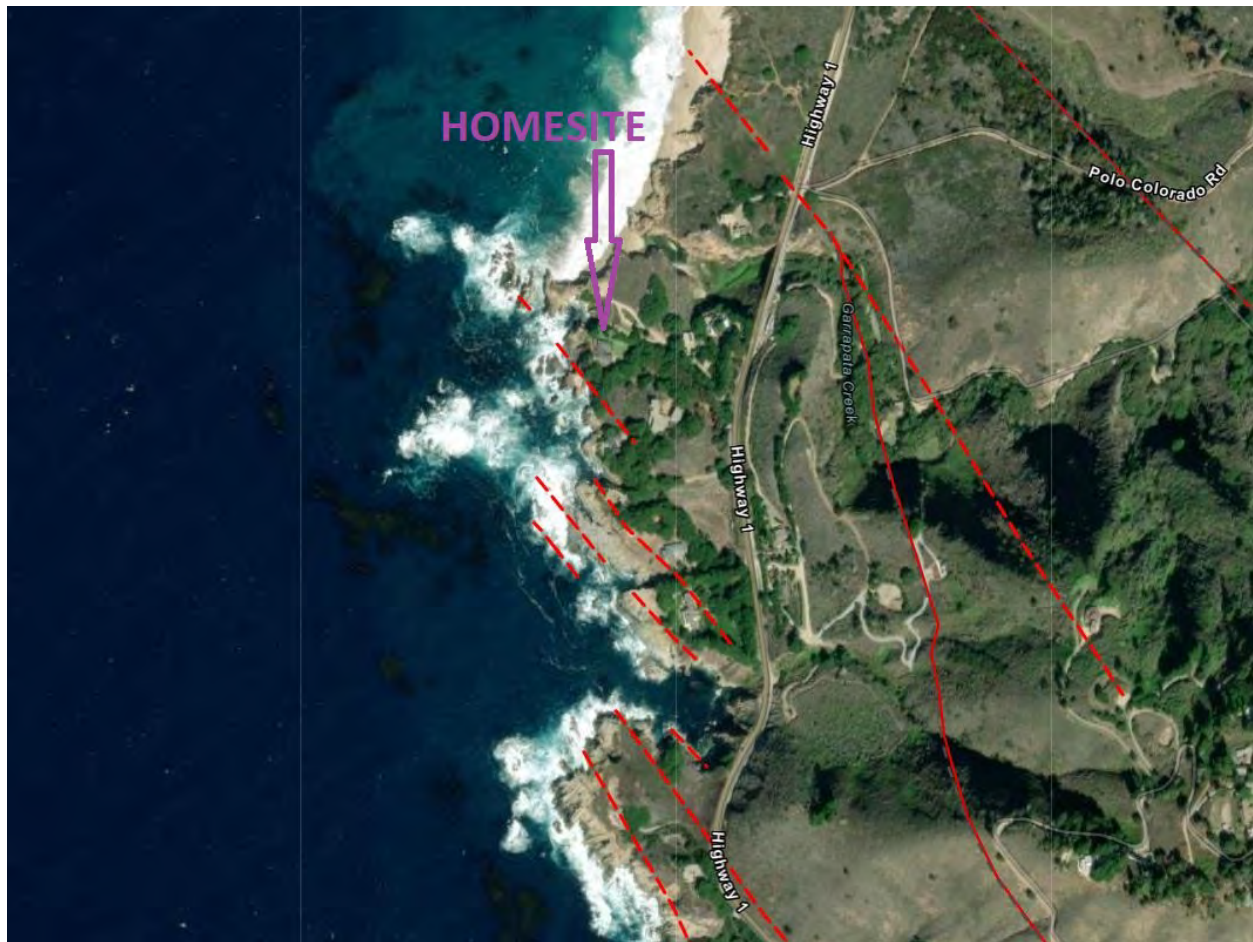
**Figure 8: Close Up View of the Monterey County GIS Geologic Hazards Map  
Showing Mapped Fault Near Property**

As shown on this map, the primary fault in the immediate vicinity of the property are the Palo Colorado Fault which comes onshore about 1.8 miles north of the property, and the Sur Fault which comes onshore about 0.9 miles south of the property. Both the Palo Colorado Fault and the Sur Fault have been interpreted to be part of the active San Gregorio-Hosgri fault complex, which is a major fault system in California.

Figure 8 shows a view of the relationship of the position of the closest mapped faults to the property on the Monterey County GIS Geologic Hazards map.

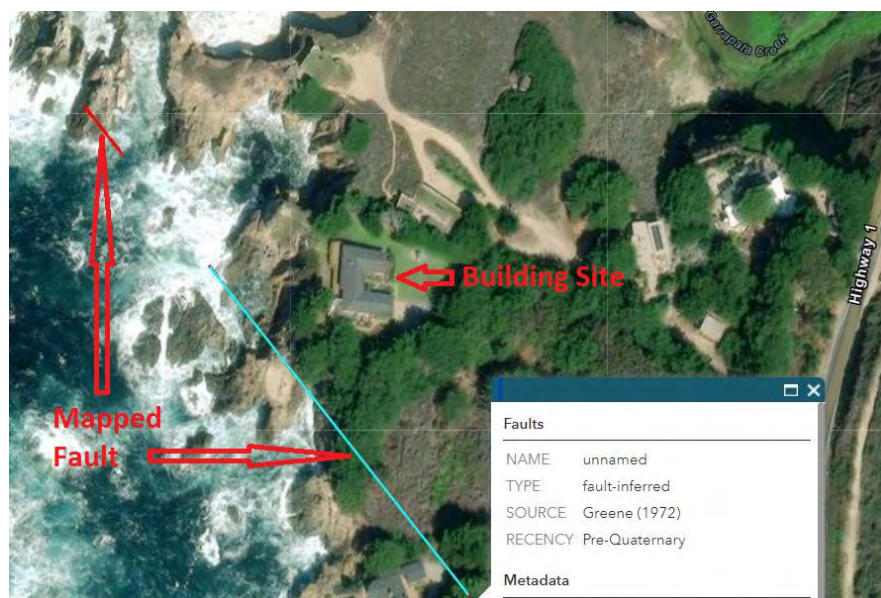
**Figure 9: Monterey County GIS Map Showing Site with Local Discontinuous Inactive Fault In Relation to Proposed Building Site (at Existing Home Location) at 35700 Highway 1 with Metadata Identifying Fault Attributes**

The published online Monterey County GIS Map (Figure 9) which shows a short discontinuous fault in the immediate vicinity of the property notes that fault a-is an inferred pre-Quaternary age fault mapped by Gary Greene in 1972. It goes through a seacave complex seaward of the home. This fault does not pose a significant hazard to the existing home or a proposed new home, because based upon it's age it is classified as inactive. Examination of the bluff face and the ceilings of the seacaves in the vicinity of the mapped inactive faults revealed no evidence of active faulting. A fault trace was observed upcoast of and seaward of the residence in the bedrock at the base of the coastal bluff. During our site traverse, our observations were that this fault trace did not displace the overlying terrace deposits; indicating it has been inactive for approximately 100,000 years. We interpret that this fault and the fault mapped by Greene are secondary fault splays that is part of a broad shear zone between the Rocky Creek Fault and the Palo Colorado Fault portrayed on Figure 7. Figure 9 (below) shows the fault mapped by Greene:

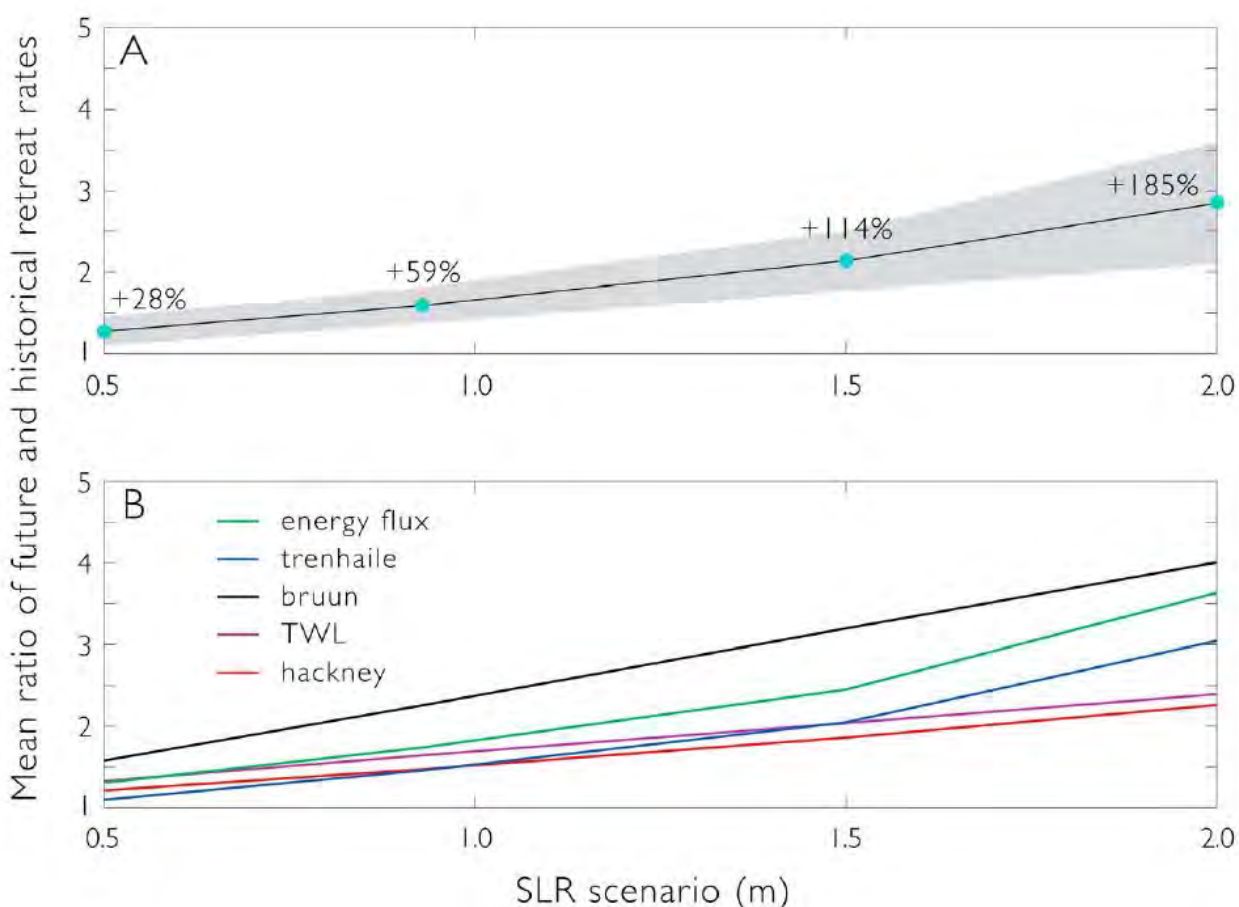
As predicted by Limber, P. W., Barnard, P. L., Vitousek, S., & Erikson, L. H. (2018) in "A Model Ensemble for Projecting Multidecadal Coastal Cliff Retreat During the 21st Century. *Journal of Geophysical Research:Earth Surface*, 123(7), 1566–1589" (<https://doi.org/10.1029/2017JF004401>) and shown in Figure 15 below, the ratio between projected and historical retreat rates for 0.93 meters SLR increase by about 59%, and the ratio between projected and historical retreat rates for 1.5 meters SLR increase by about 114%. For a 4.6 foot (1.4 meter sea level rise (see Table 2 above) in Monterey by 2100 the rate of bluff retreat is predicted to increase by approximately 100%. That rate is based

upon a Medium-High Risk Aversion inclination to avoid taking risks in the face of uncertainty which the "State of California – Sea-Level Rise Guidance 2024" document indicates is appropriate for less adaptive, long lifespan (i.e., 2075 and beyond), more vulnerable projects that will experience medium to high consequences if impacted because of underestimating sea level rise. If a Medium Risk Aversion inclination were selected, only a 59% increase in the rate of future bluff retreat is predicted for a 3.1 foot (0.94 meter) sea level rise (see Table 1 above) in Monterey by 2100.

The rate that sea level is rising at is accelerating, and increased bluff recession rates will result from that. Figure 15 shows that the resulting rate of bluff recession is projected to be about 100% higher 75 years from now than it is today in Monterey. This does not indicate that the cumulative amount of bluff edge retreat will increase by 100% by then, compared to the retreat that has occurred in the past 75 years (since about 1950). It does suggest that the cumulative amount of bluff edge retreat will increase by about 50% between now and 75 years from now (2099) compared to the amount of retreat that has occurred in the past 75 years (since about 1950).
