# Salinas River Stream Maintenance Program Effectiveness Assessment

Presentation to MCWRA Board

October 20, 2025

Resource Conservation District of Monterey County

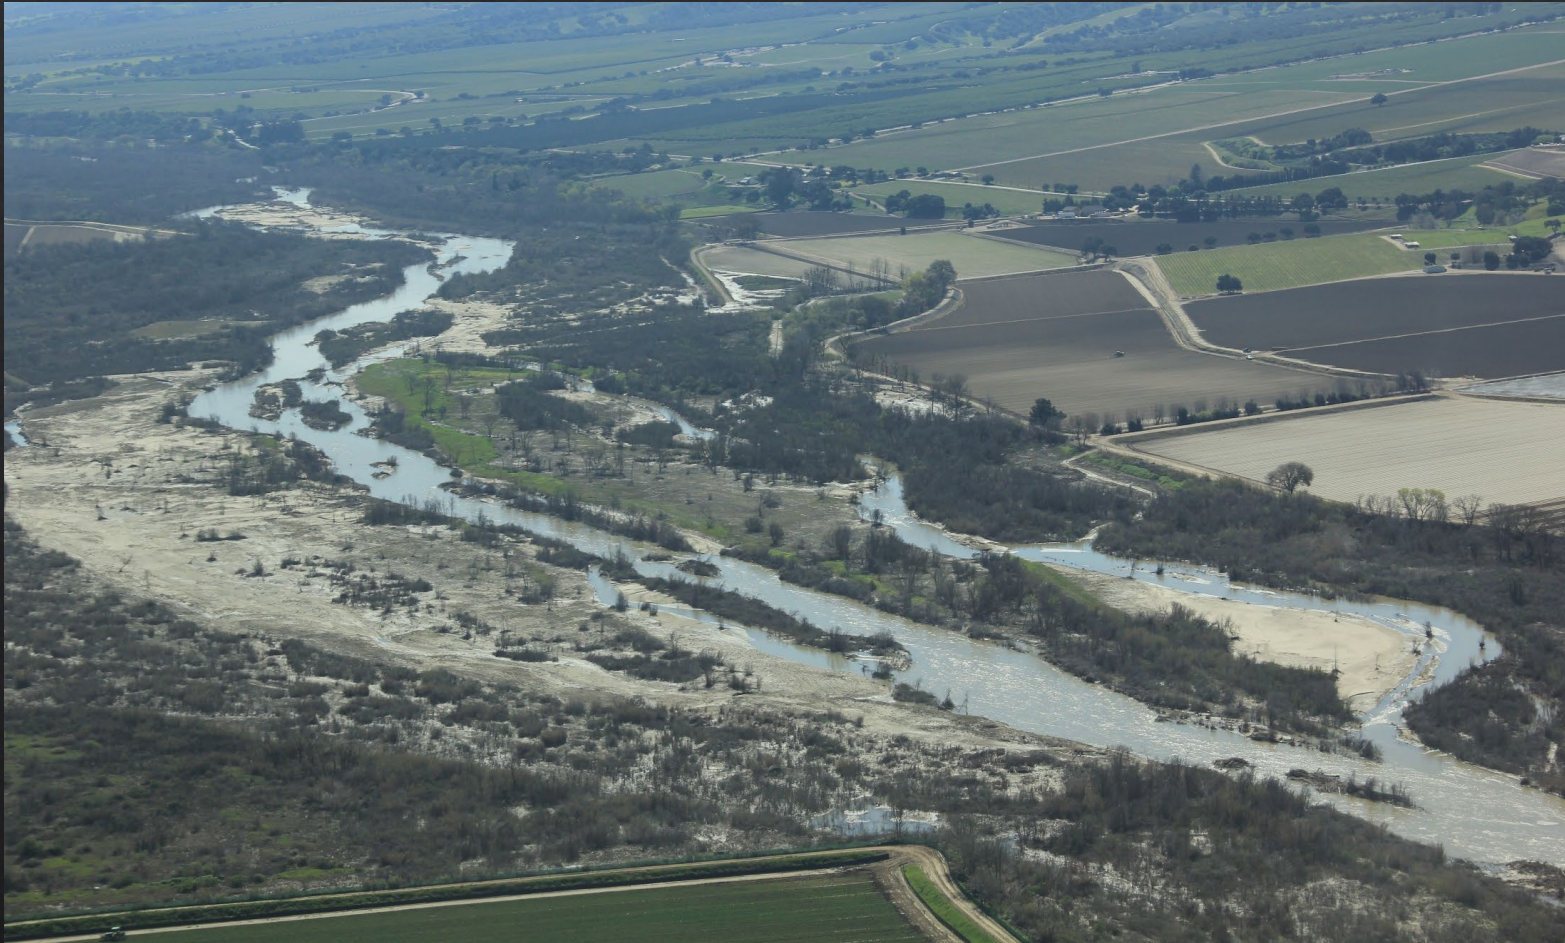
- ◆ Secondary channels are “activating” during moderate flow events, creating braided channel
- ◆ [Possible groundwater benefit under investigation]

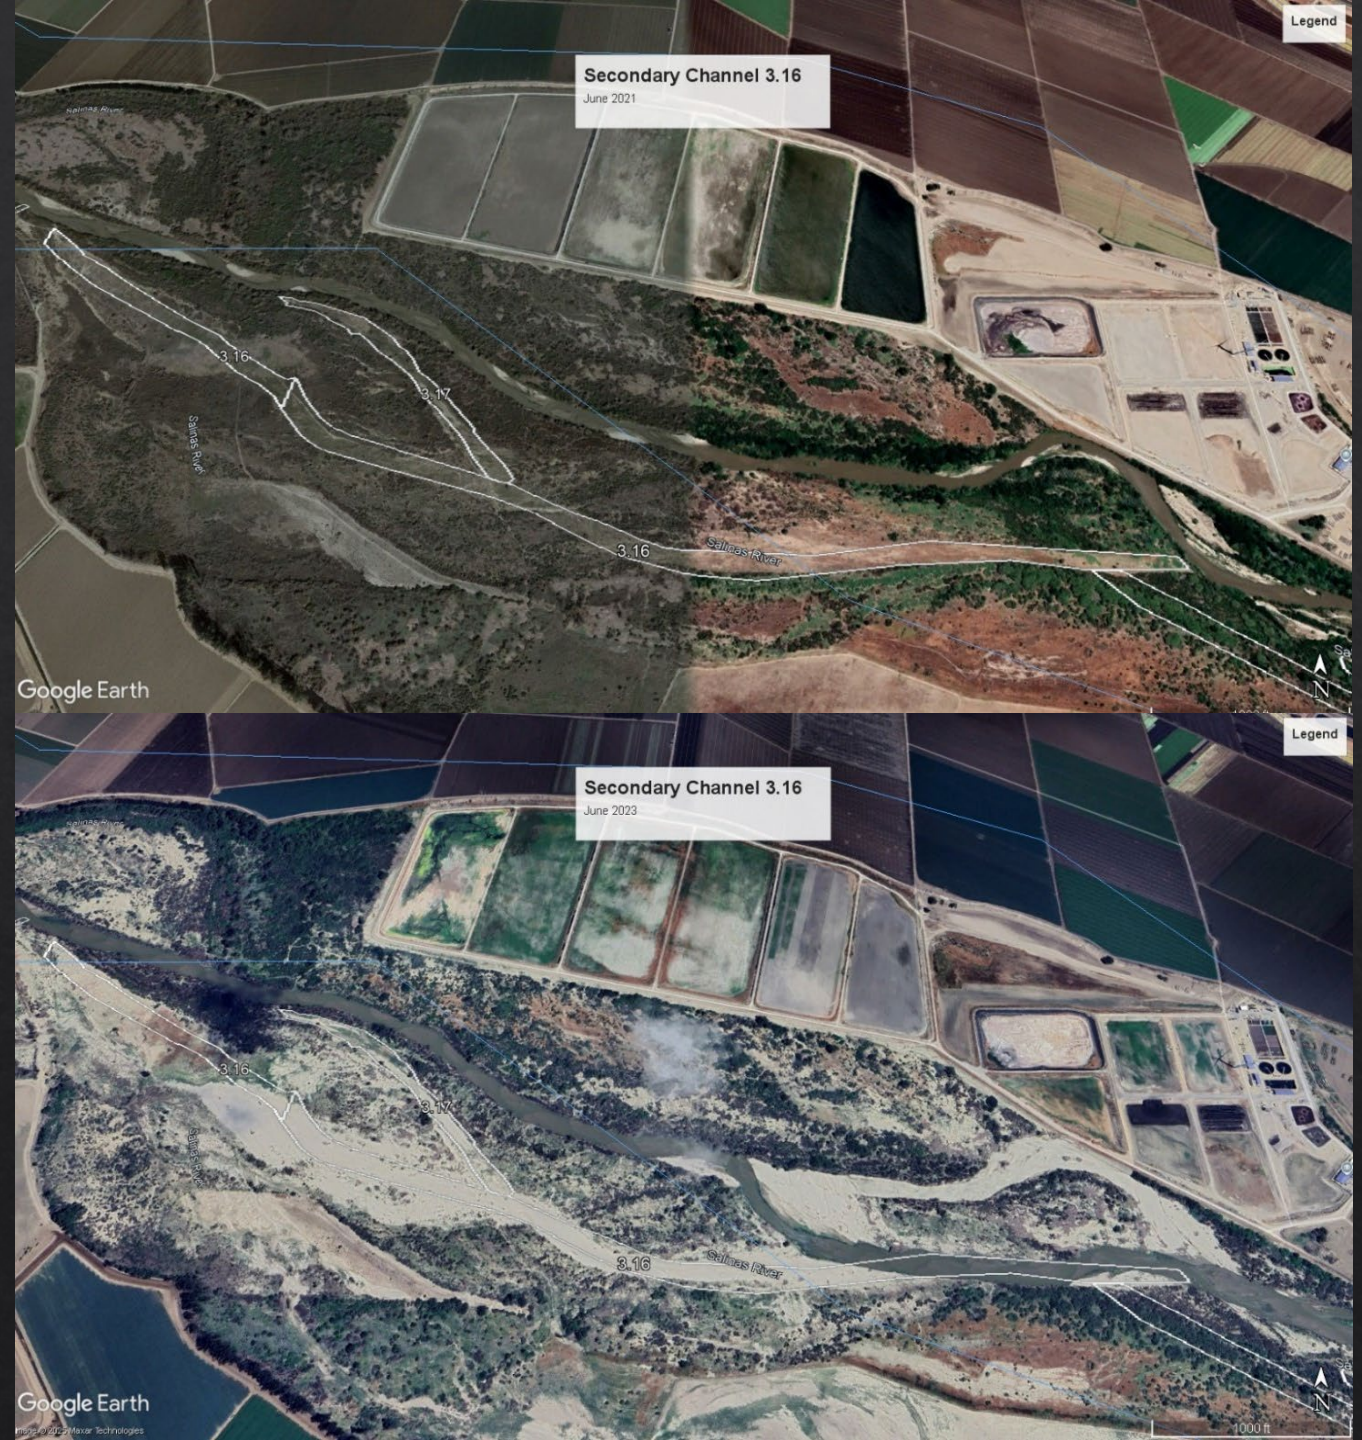
- ◇ River has shifted away from banks into maintained secondary channels
- ◇ Reduces bank erosion
- ◇ Levee breaching observed in 2023 in areas where vegetation is thick and secondary channels were not present

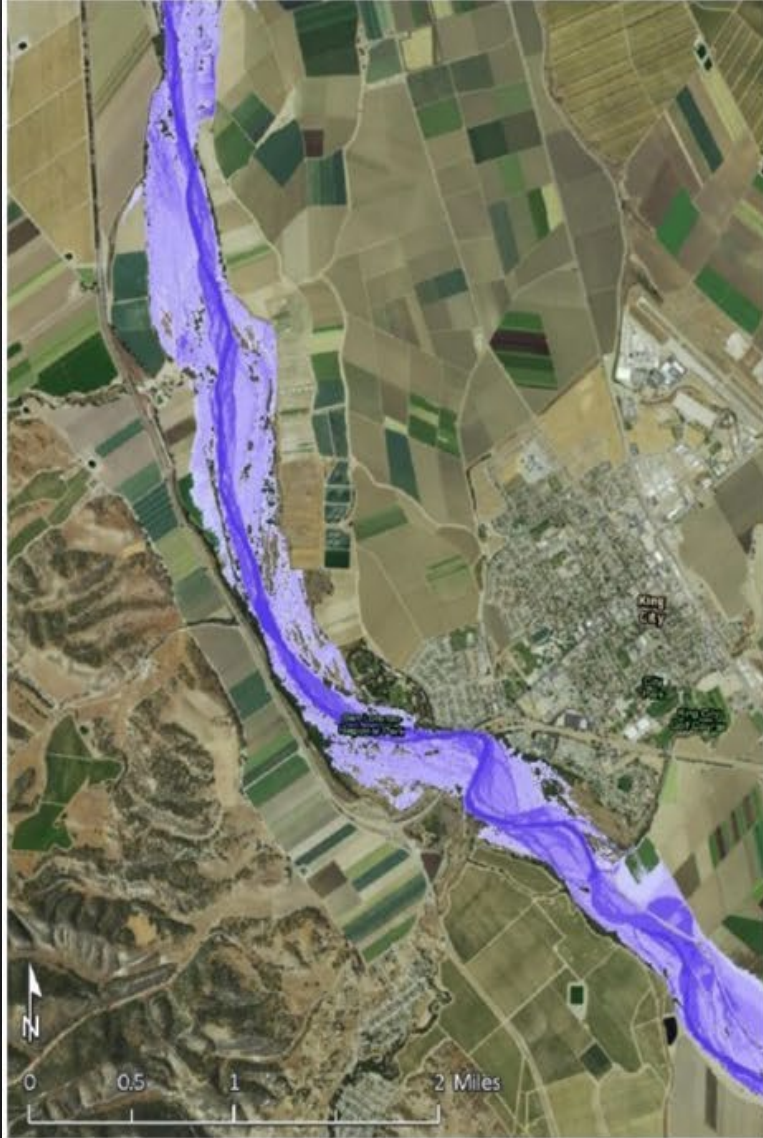
Modeled 5-year Flow Depths RMU 1, King City

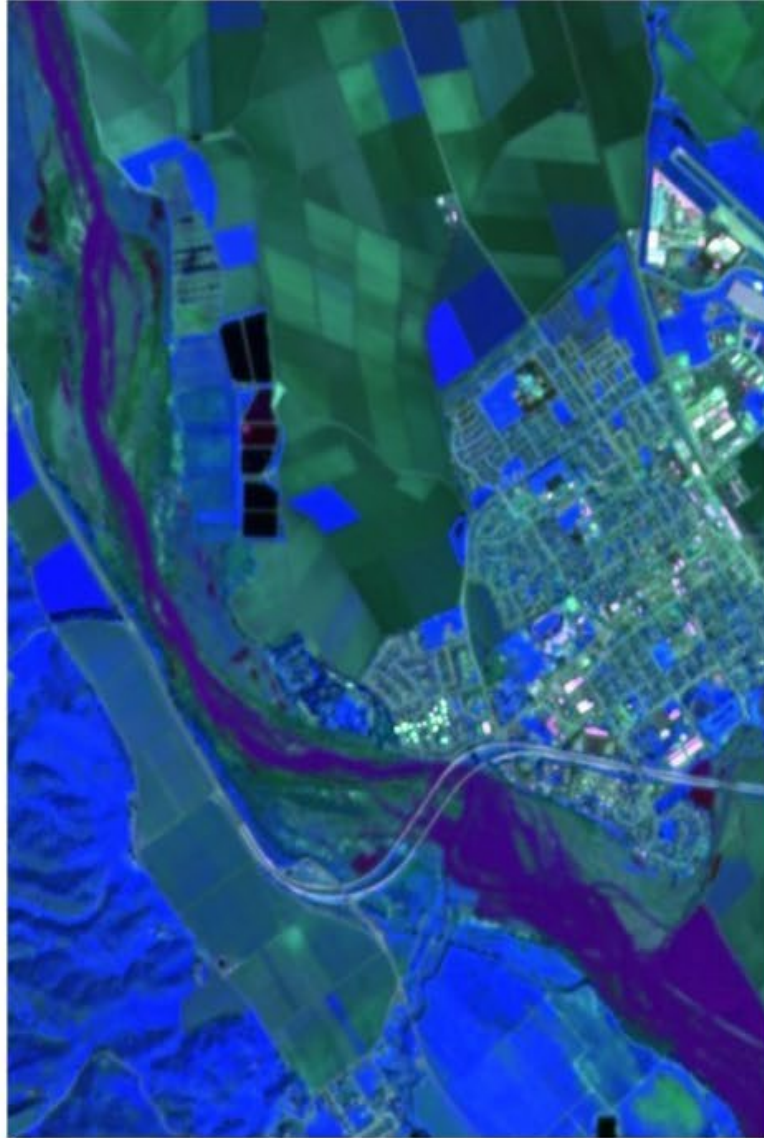
Copernicus Data Ecosystem 2023 flood event

- ◆ 42,800 cfs at Spreckles considered 10-year event
- ◆ 2023 gage at Spreckels = 23,300 cfs
- ◆ [Note: gages may not accurately measure flood events!]
- ◆ Used aerial imagery of March 2023 event from Copernicus Data Space Ecosystem to compare observed vs. modeled

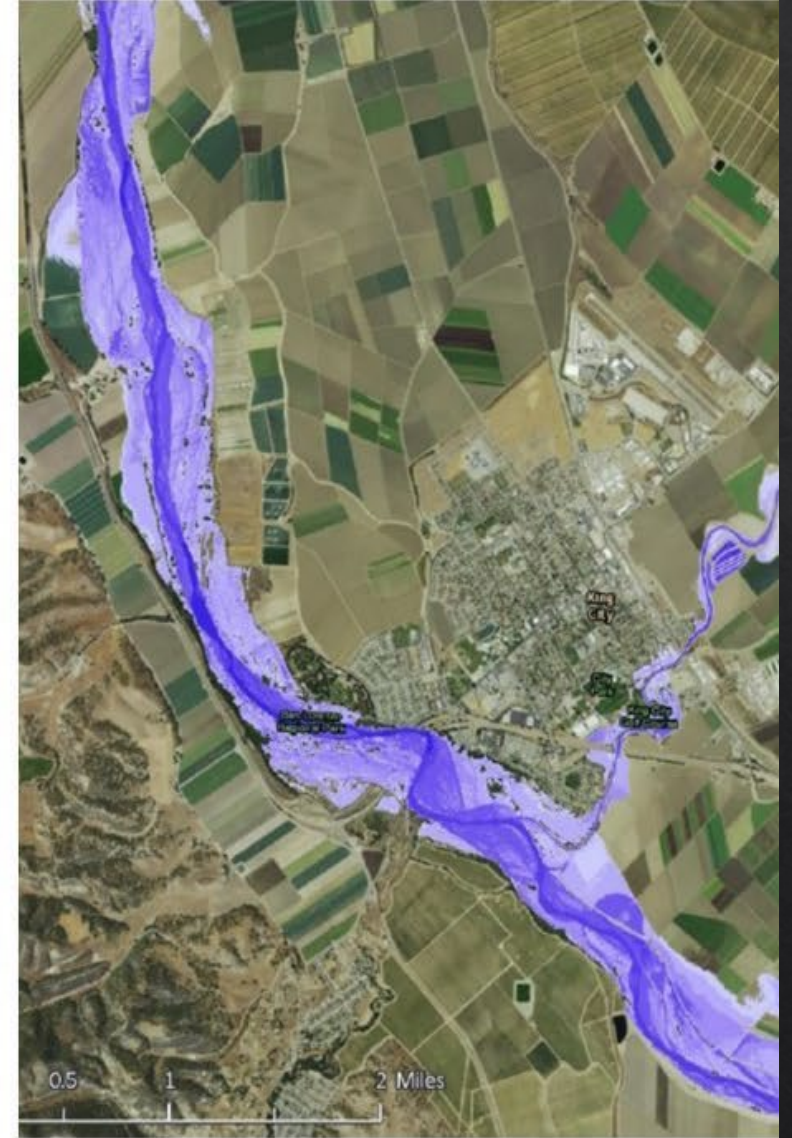
Modeled 10-year Flow Depths RMU 1, King City

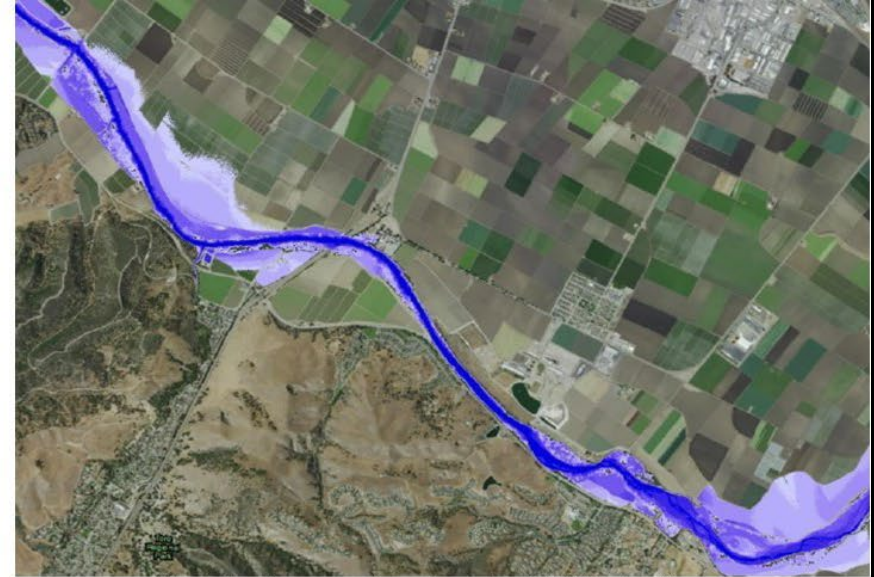
Modeled 5-year Flow Depths RMU 6, Salinas

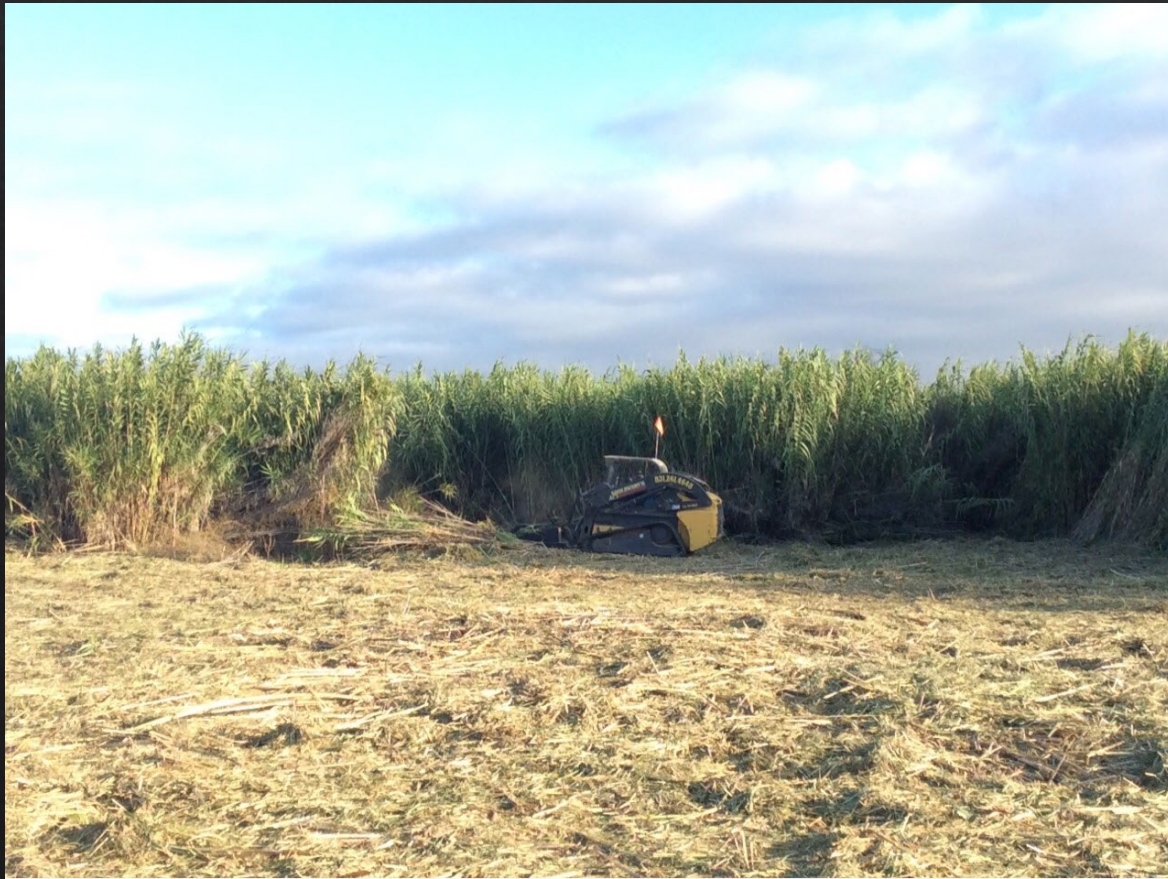
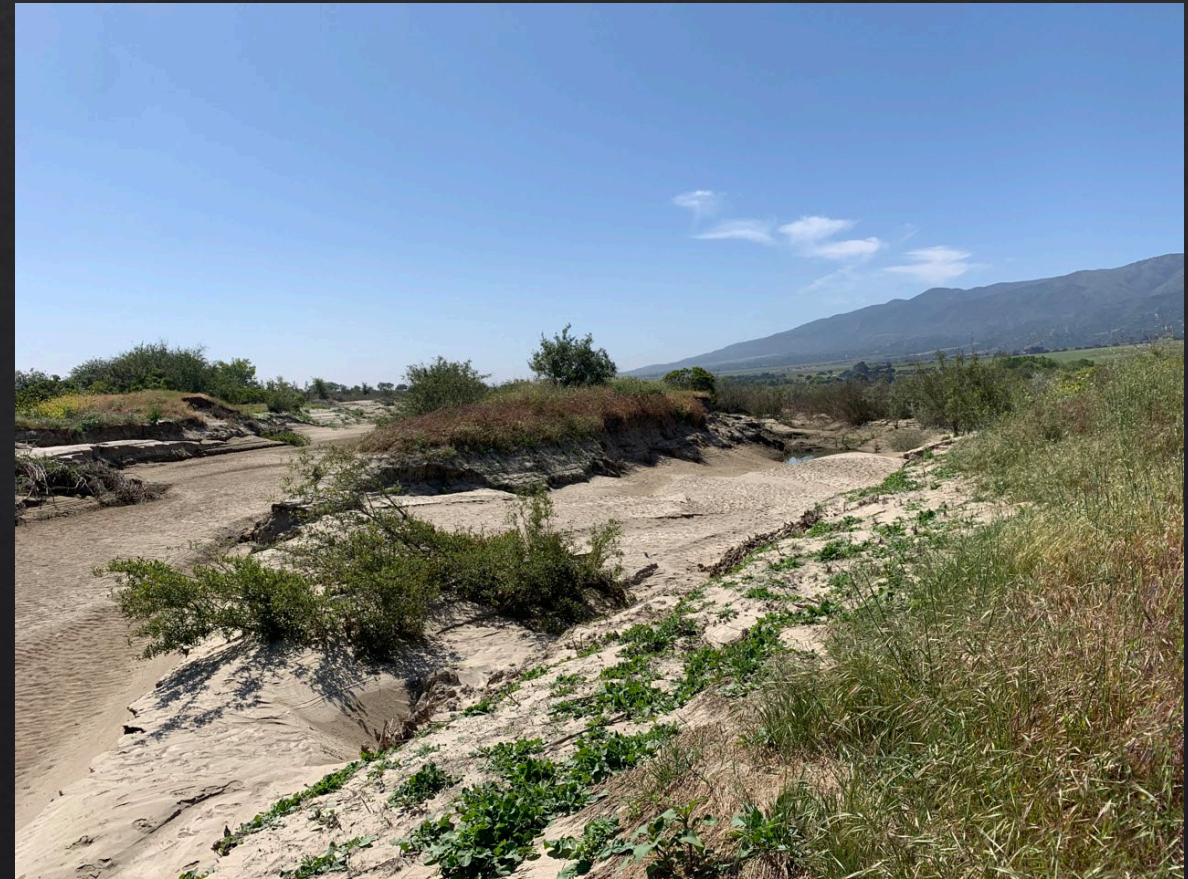
- ◆ Arundo mitigation has opened space for native vegetation and increased habitat diversity
